## LAND AT CHICHELE ROAD, OXTED: BADGERS

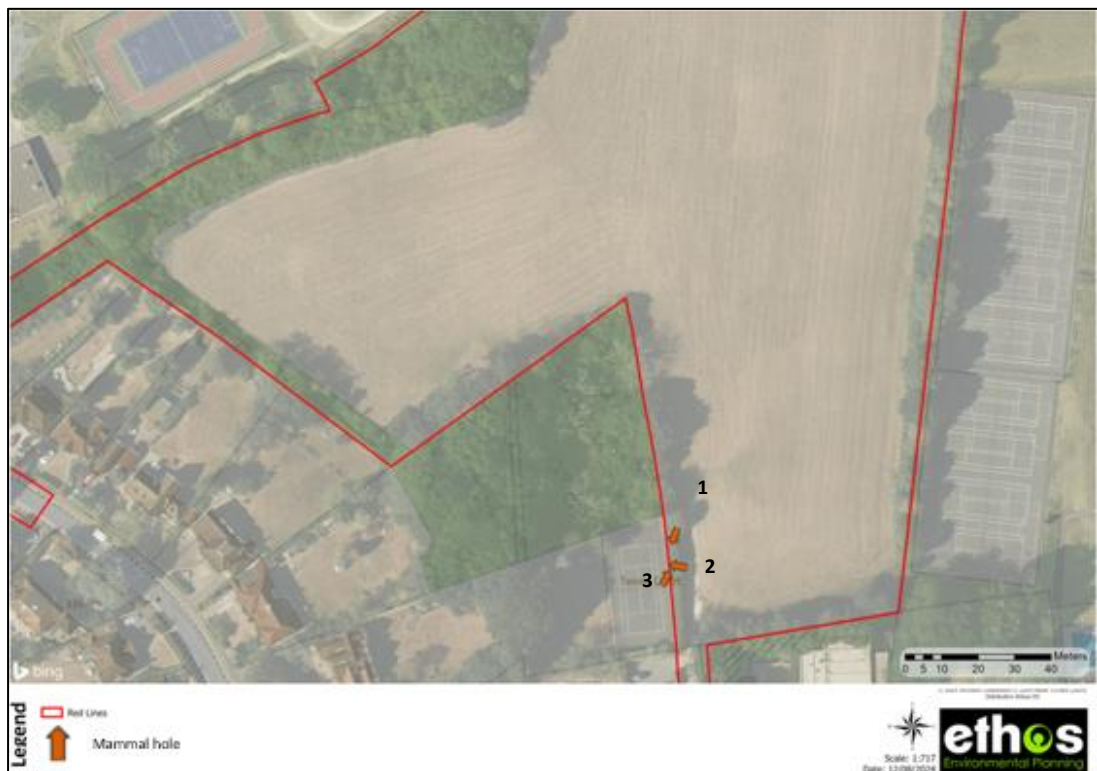
3.1 The badger walkover survey found potential signs of badger on site in the form of three mammal holes in the south of the site near to an existing entrance (see figure 1).

Figure 1 Mammal holes along southernmost southwest boundary

- 3.2 A mammal track led from the holes along the fence line and to the offsite woodland. The northern hole was quite vertical in its underground trajectory; the middle hole led directly under the wooden fence line offsite and the third hole was partially filled with leaf litter. No field signs of badger were found near to this hole. Camera trap surveys were carried out to monitor use of these holes.

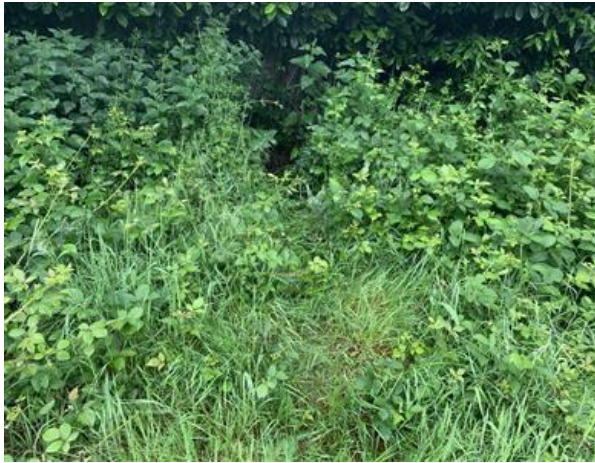
Photo 1 Mammal trail leading to hole 1

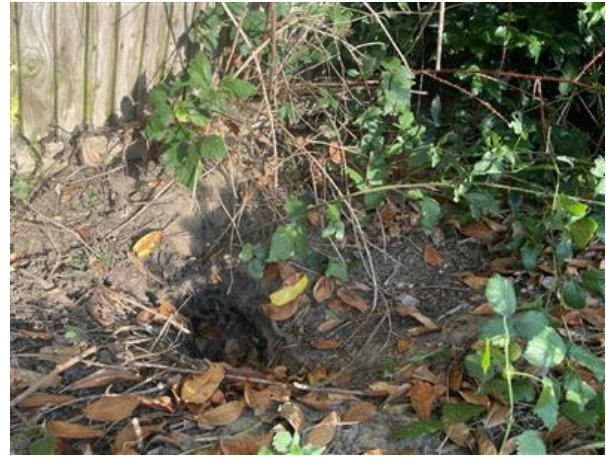
Photo 2 Hole 1 in proximity to the fence

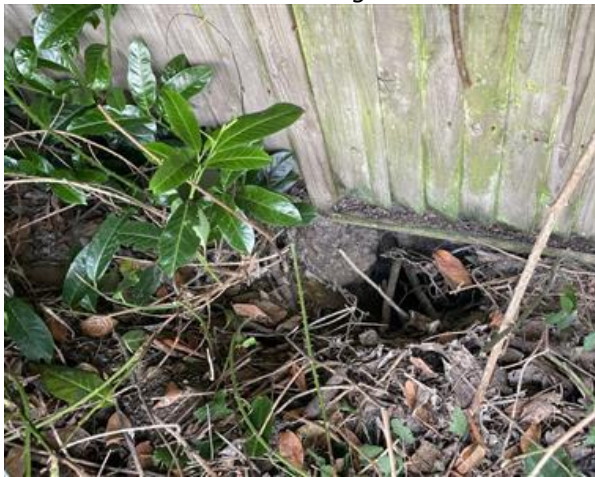
Photo 3 Hole 2, under fence

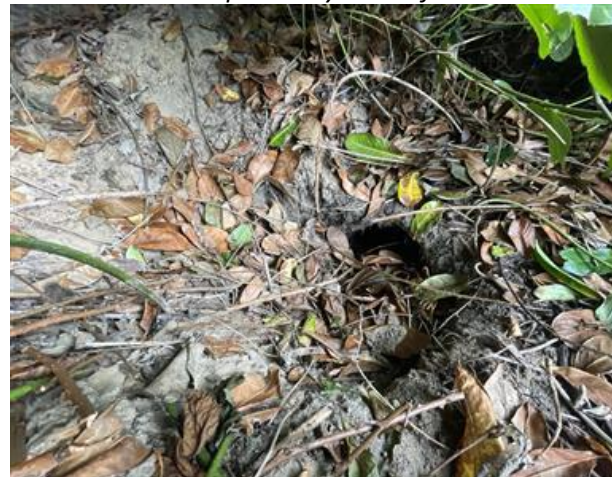
Photo 4 Hole 3 in proximity to the fence

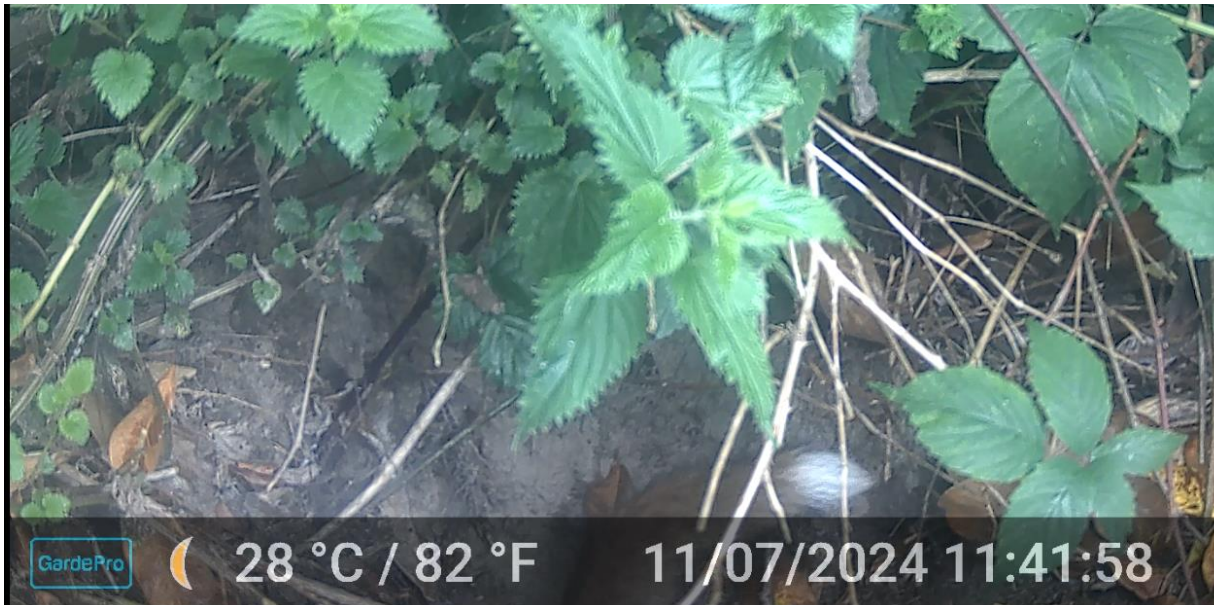
- 3.3 The camera trap surveys recorded a single badger (a cub) passing the area, however there was no evidence of the badger entering or exiting any of the holes. Other videos recorded fox entering/exiting on of the holes with suitable time elapsing in-between to confirm the hole is used by fox for resting.
- 3.4 One sighting of badger was recorded during a bat transect survey onsite. A badger cub was seen on 1<sup>st</sup> June towards the south of the site by the fence line. The badger commuted away through the entrance gate at the south of the site.

Photo 5 Fox entering hole 1

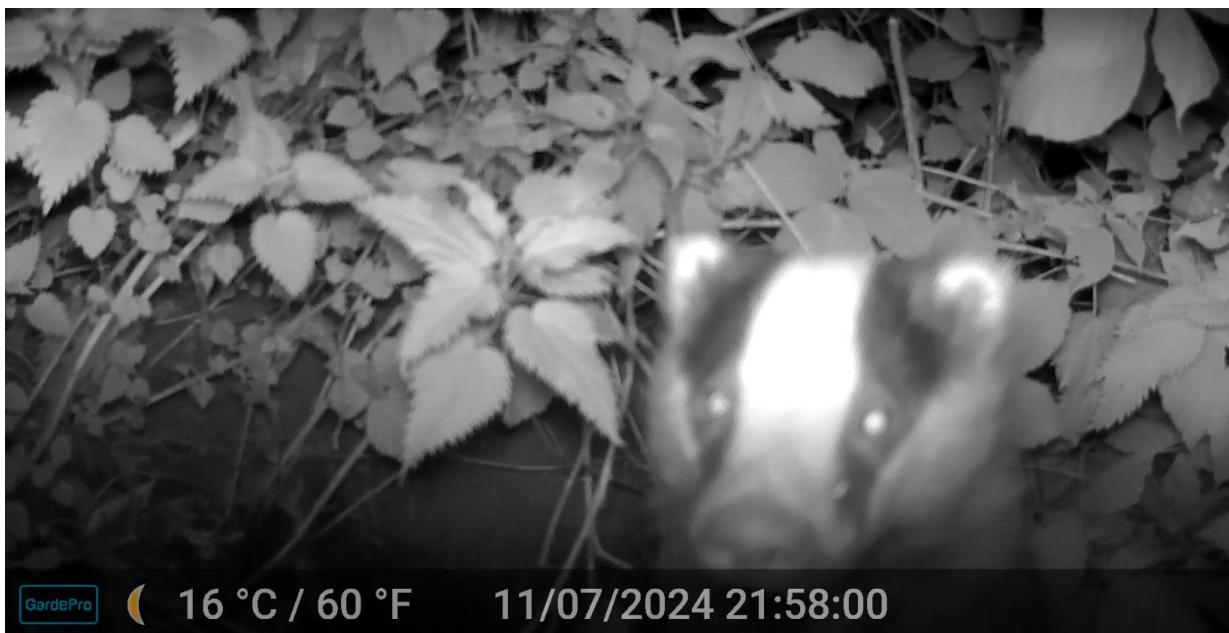
Photo 6 badger commuting and investigating camera
